July 2, 2009

Re: Jackson – Stormwater Discharge
Bolton (T), Warren Co.
Application No. 5-5220-00338/00001
SPDES Permit NY-0265691

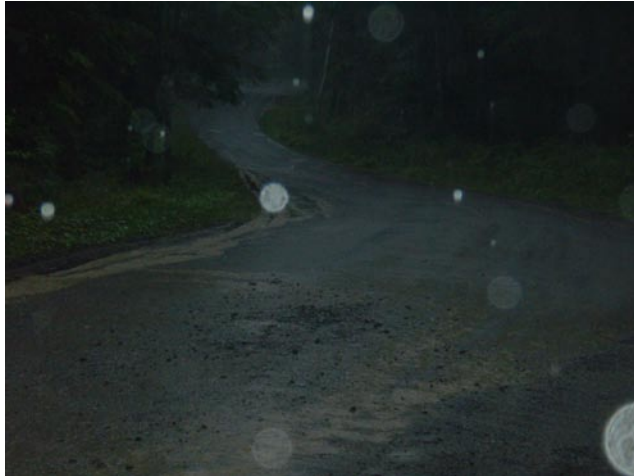
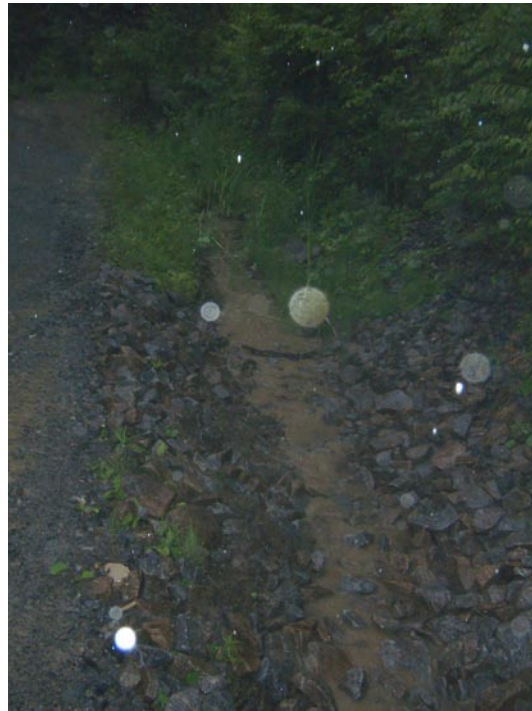
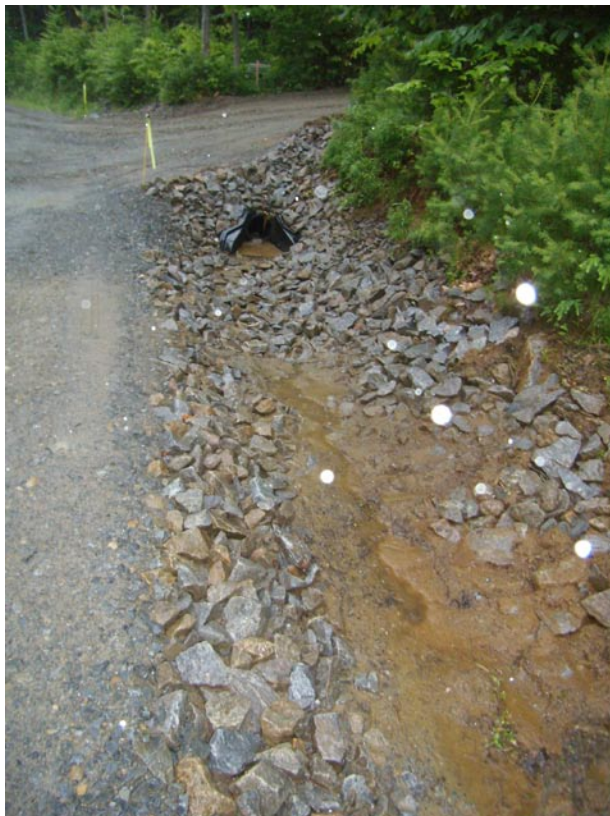
Photographs of Deer Creek Road on June 30, 2009 showing sediment entering the public road and drainage ditch from the Jackson construction site. Photo below shows runoff flowing off roadway into wetland area.

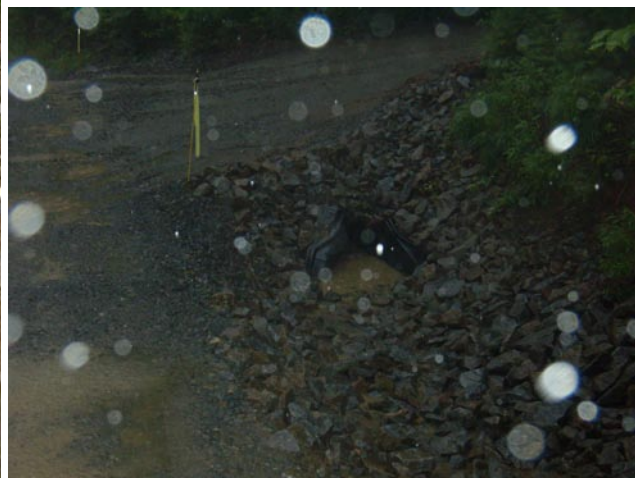
Photographs of culvert under Jackson driveway taken on June 30, 2009. Photo on left was at the beginning of a rain event. Photo on right was taken 20 minutes into rain event. Notice the increase in sediment laden runoff at the entrance to culvert. Photo directly above is of culvert discharge during rain event.

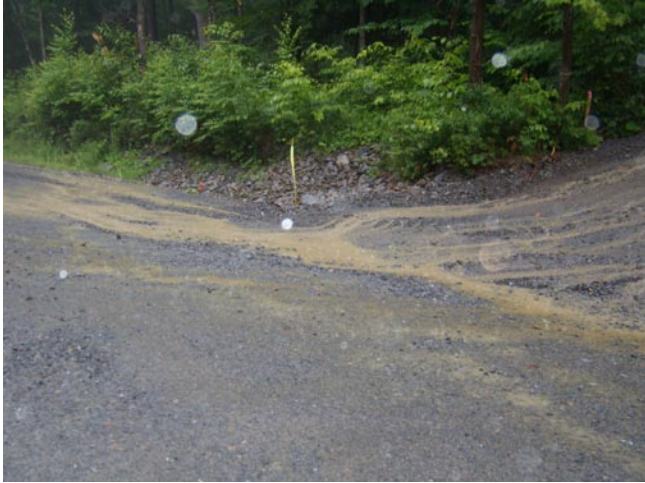
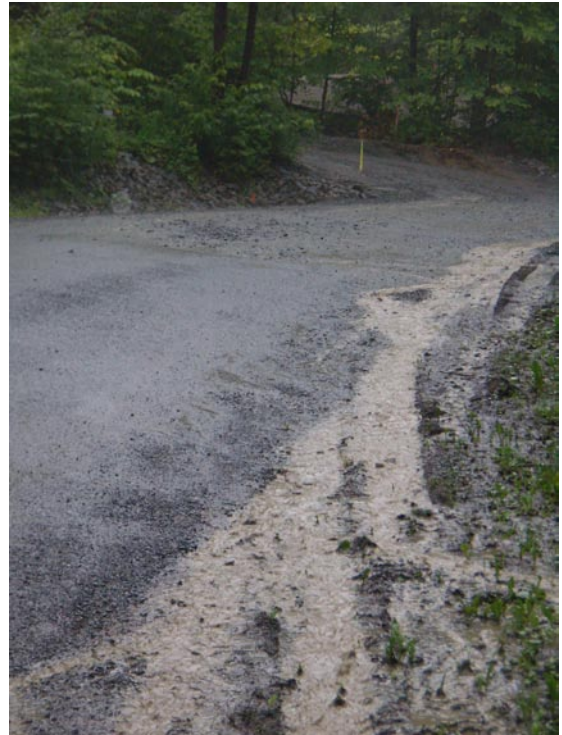
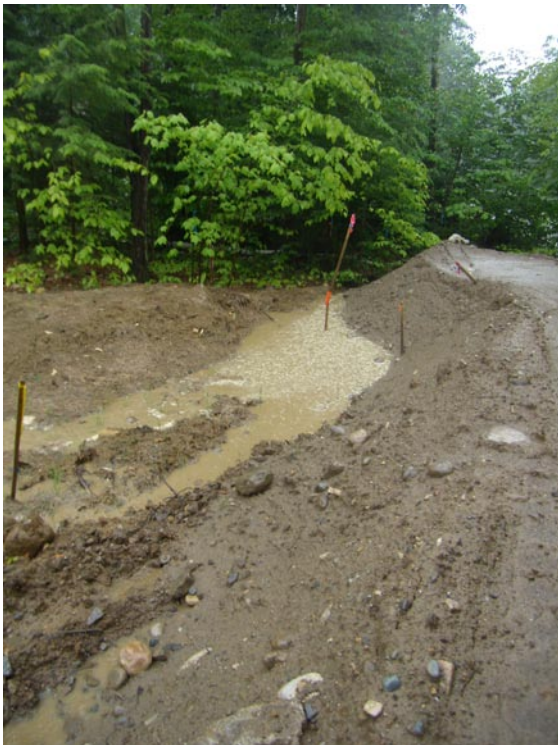
Photographs taken on July 1, 2009 on Deer Creek Road. Photos document sediment laden runoff flowing off the driveway untreated and off the site.

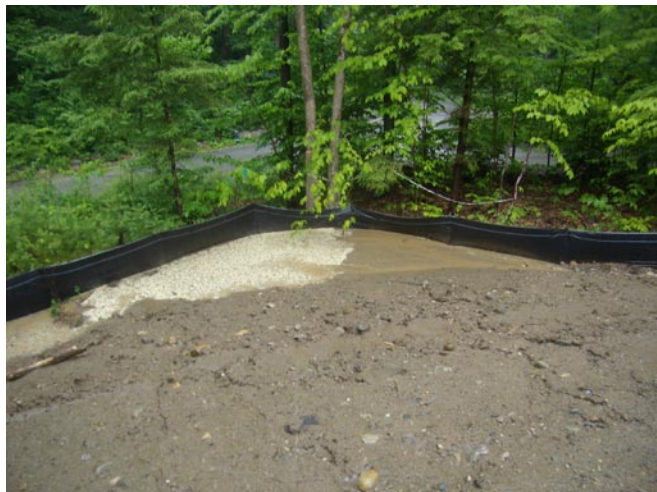
Photographs of sediment controls at base of driveway which are failing or where maintenance is neglected. On the left, runoff flows around the earthen berm of the sediment impacted lower infiltration basin. Below, sediment is 2/3 height of silt fence.
